## HANGINGSTONE RIVER BASIN STUDY

PRESENTED TO  
**Regional Municipality of Wood Buffalo**

JUNE 2015  
ISSUED FOR USE  
FILE: ENVH2O03100-01

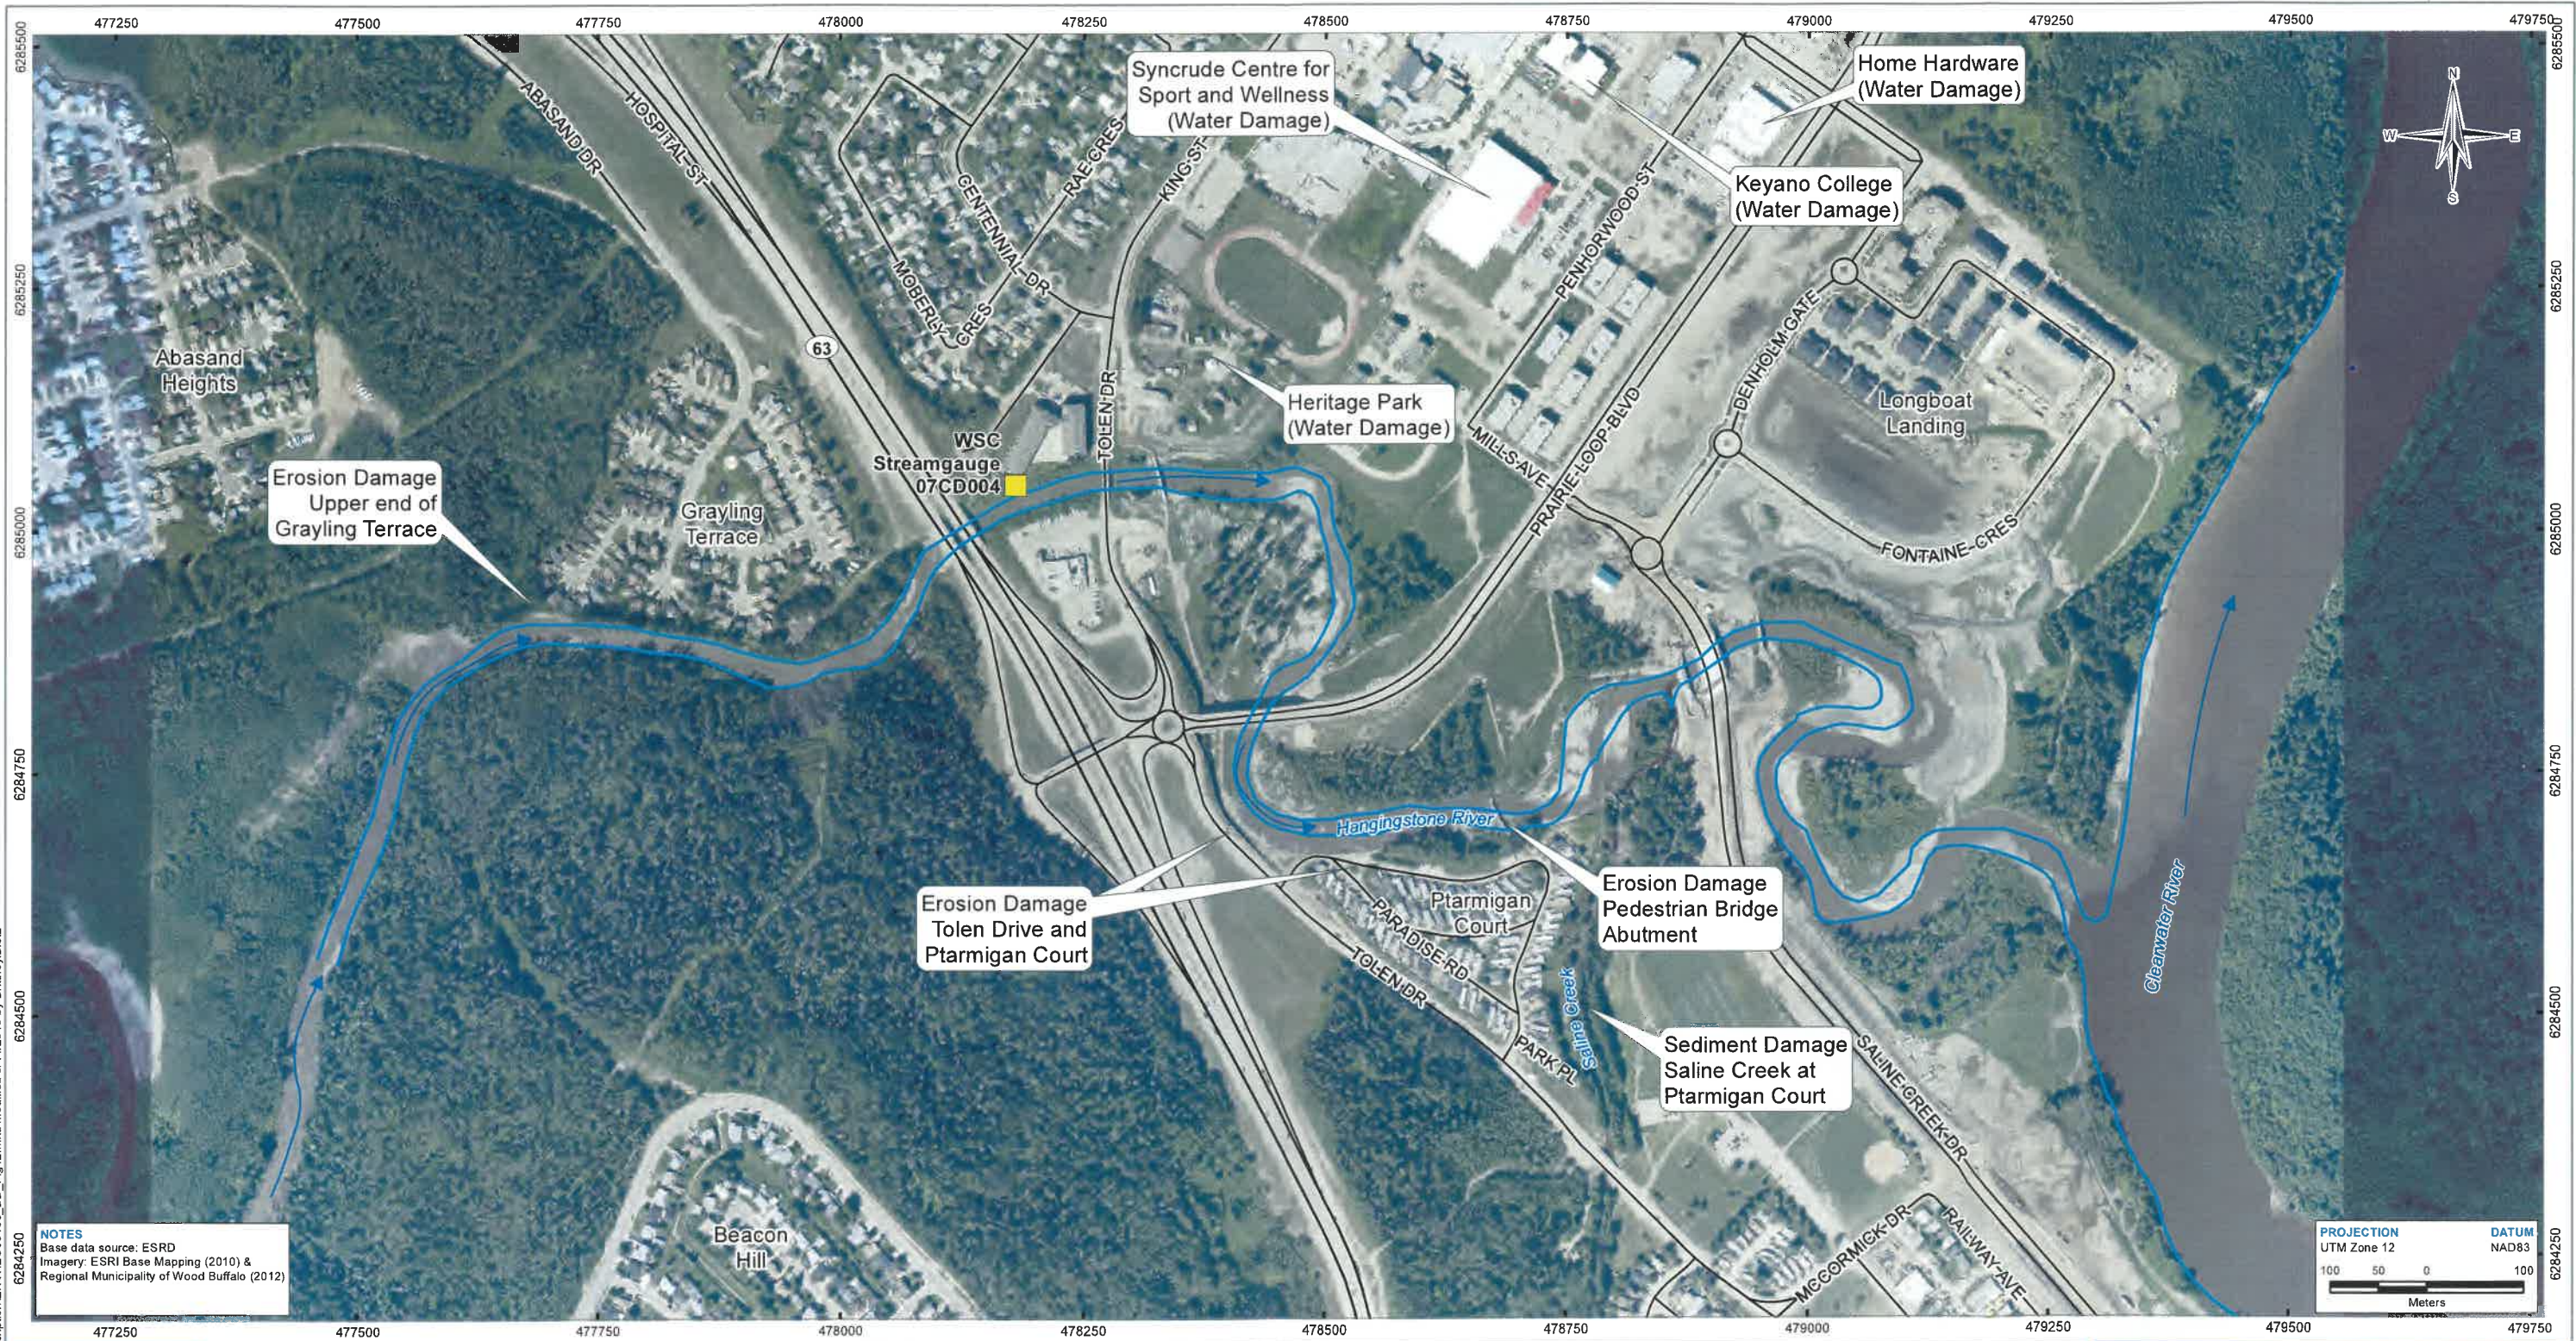
**Figure 11**

Figure 11 shows locations of groundwater wells and areas where groundwater is most susceptible to contamination from surface water. Selected geological and hydrogeological references as well as Alberta Environment (AENV) information and databases were used to compile the map to illustrate how groundwater and surface water potentially interact.

Water wells drilled in the basin are concentrated in populated and industrial water use areas. Water well records available on the AESRD database (2015) are provided on Figure 11 and show a relatively low number of wells in the basin area, primarily for localized industrial use. These wells are clustered along Highways 63 and 881 and within the Suncor Meadow Creek Lease (Figure 8).

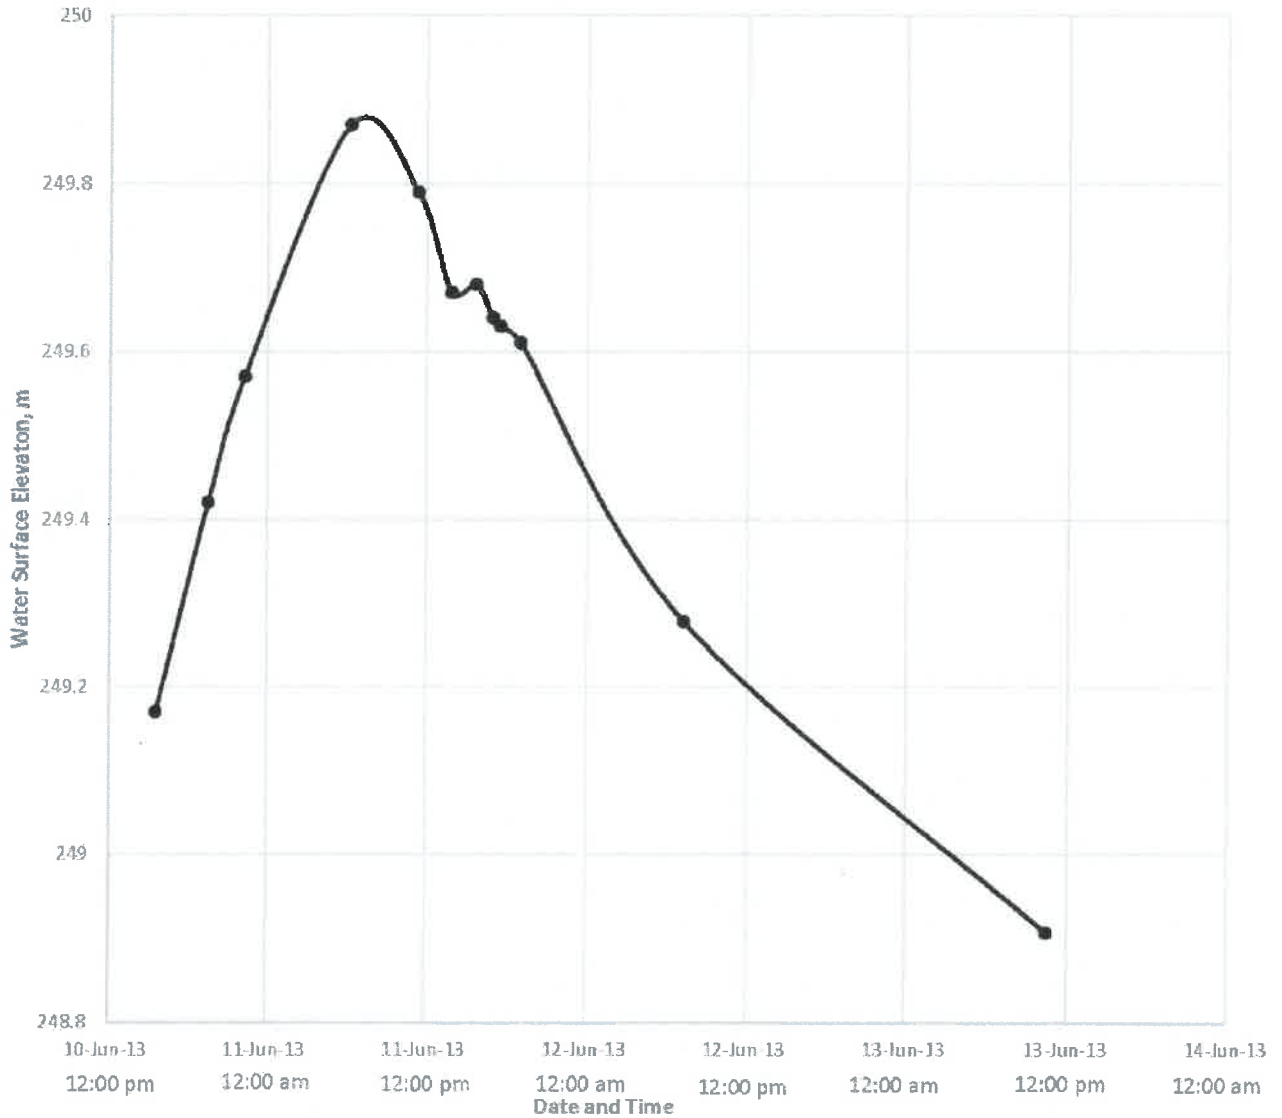
CLIENT 	
PROJECT NO. ENVH2003100-01	DWN BB	CKD MS	APVD BR	REV 0	<b>Figure 13</b>	
OFFICE T: EBA-CAL	DATE May 20, 2015

Stage Hydrograph for 2013 Flood Event  
 Hangingstone River at Fort McMurray below Highway 63  
 at WSC Gauge and Firehall No.1

**2013 Flood Stage Hydrograph  
 Hangingstone River at Fort McMurray**

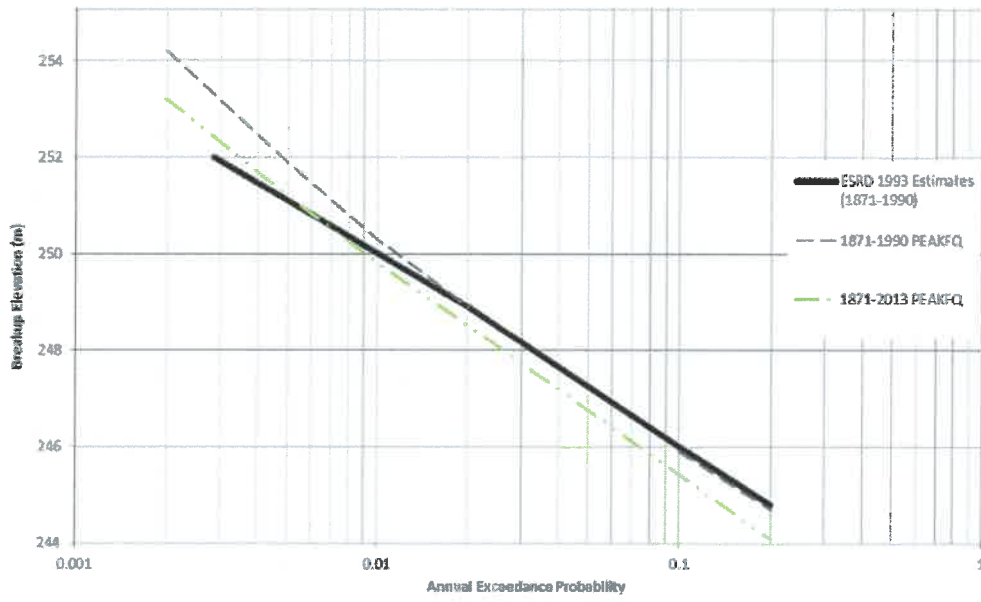
Source: Golder, 2014. Figure C- 4 of Athabasca River Basin Feasibility Study  
Fort McMurray Updated Breakup Stage Frequency - LOG PEARSON TYPE III DISTRIBUTION

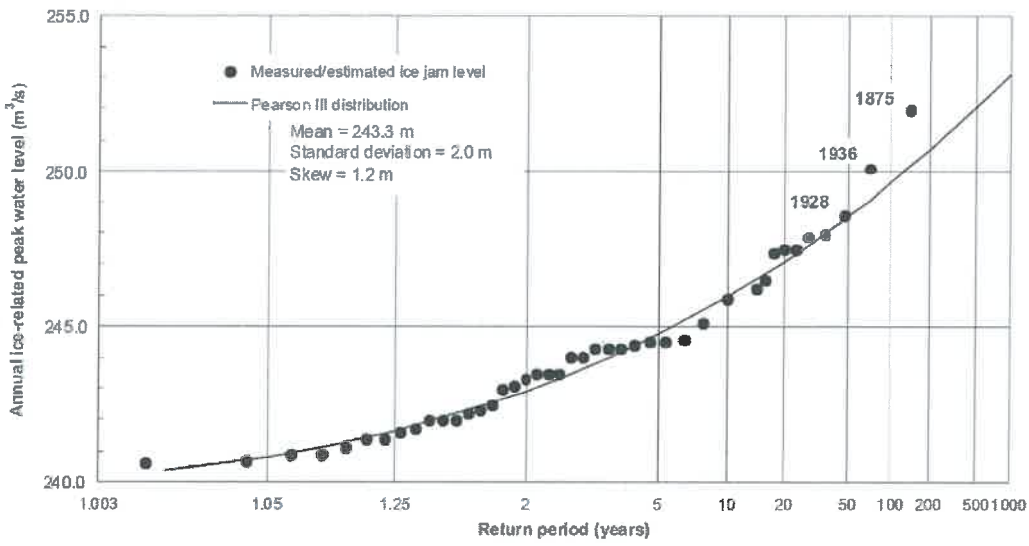
**Figure 14**

Source: NHC, 2014, Figure 3 of Fort McMurray Flood Protection Conceptual Design  
FREQUENCY CURVE OF PEAK ICE JAM FLOOD LEVELS FOR ATHABASCA RIVER AT CLEARWATER RIVER MOUTH

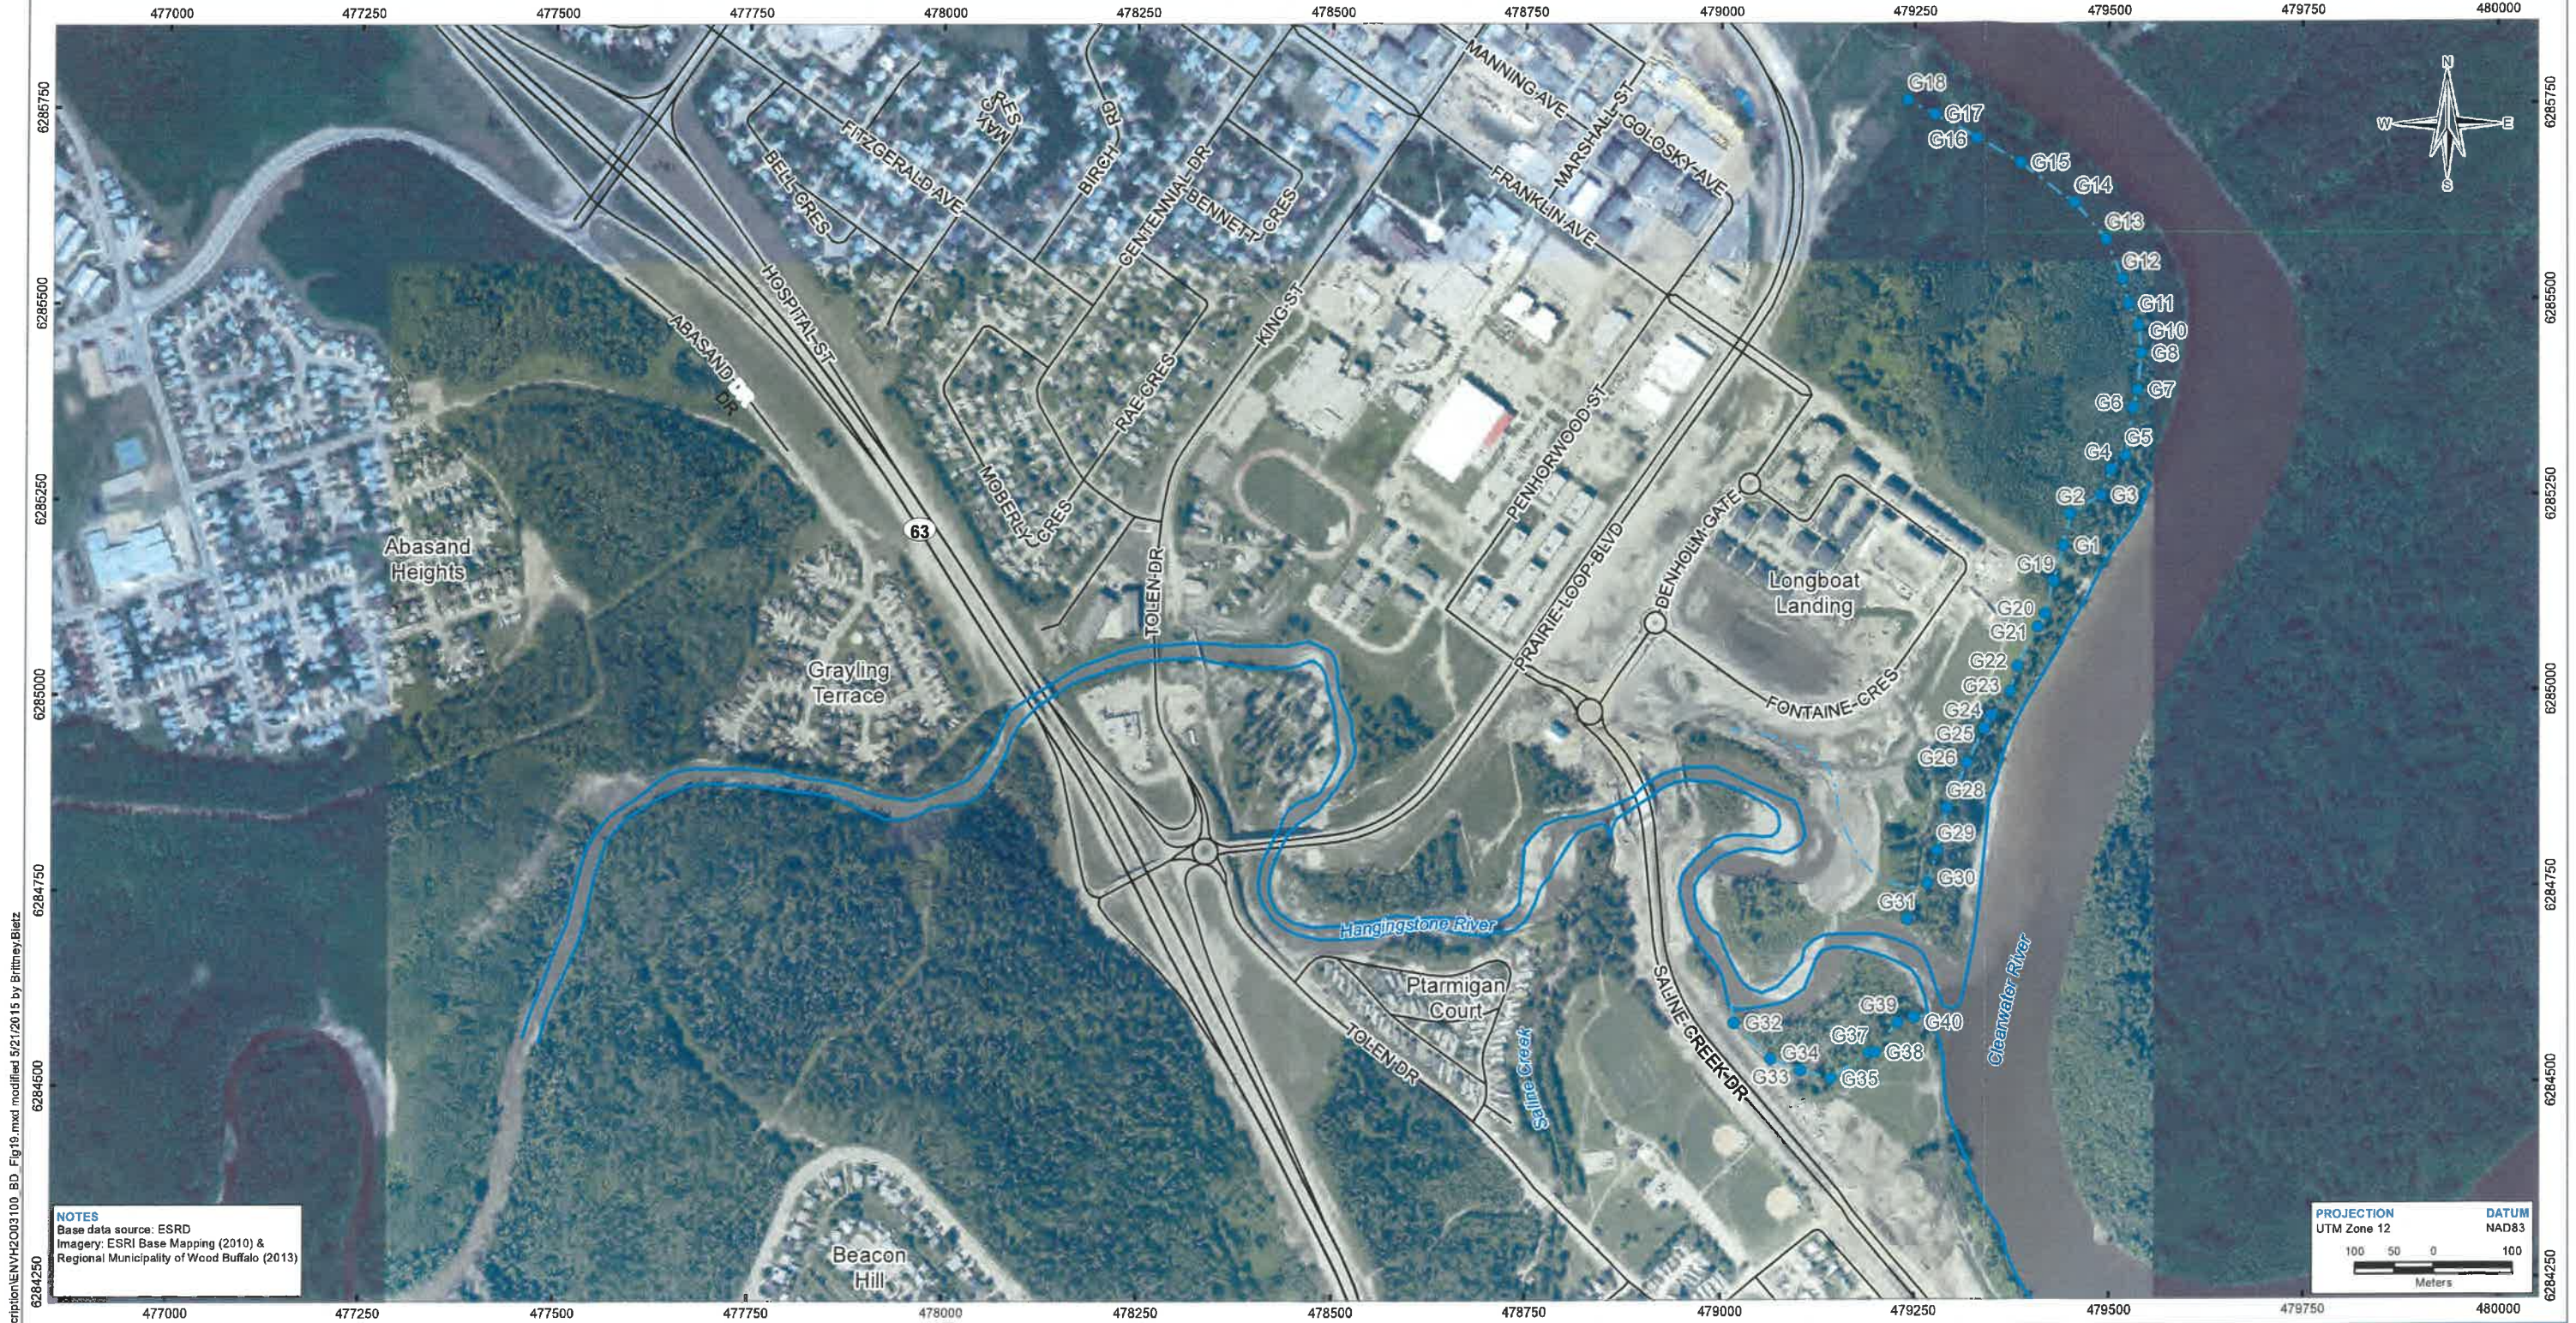
**Figure 18**

Figure 18 presents open water flood hazard lines from Figure 16 that transition to same-risk ice jam flood levels for the lower reach. For the lower reach starting at the confluence with the Clearwater River, ice jam conditions are associated with the greatest flood risk. For 100-year ice jam conditions, the transition point where the open water design flood level (2013 flood) intersects the ice jam level is located just downstream from Highway 63. This is more or less at the location of the WSC Hangingstone River gauge and RMWB Firehall No. 1 on the opposite bank.

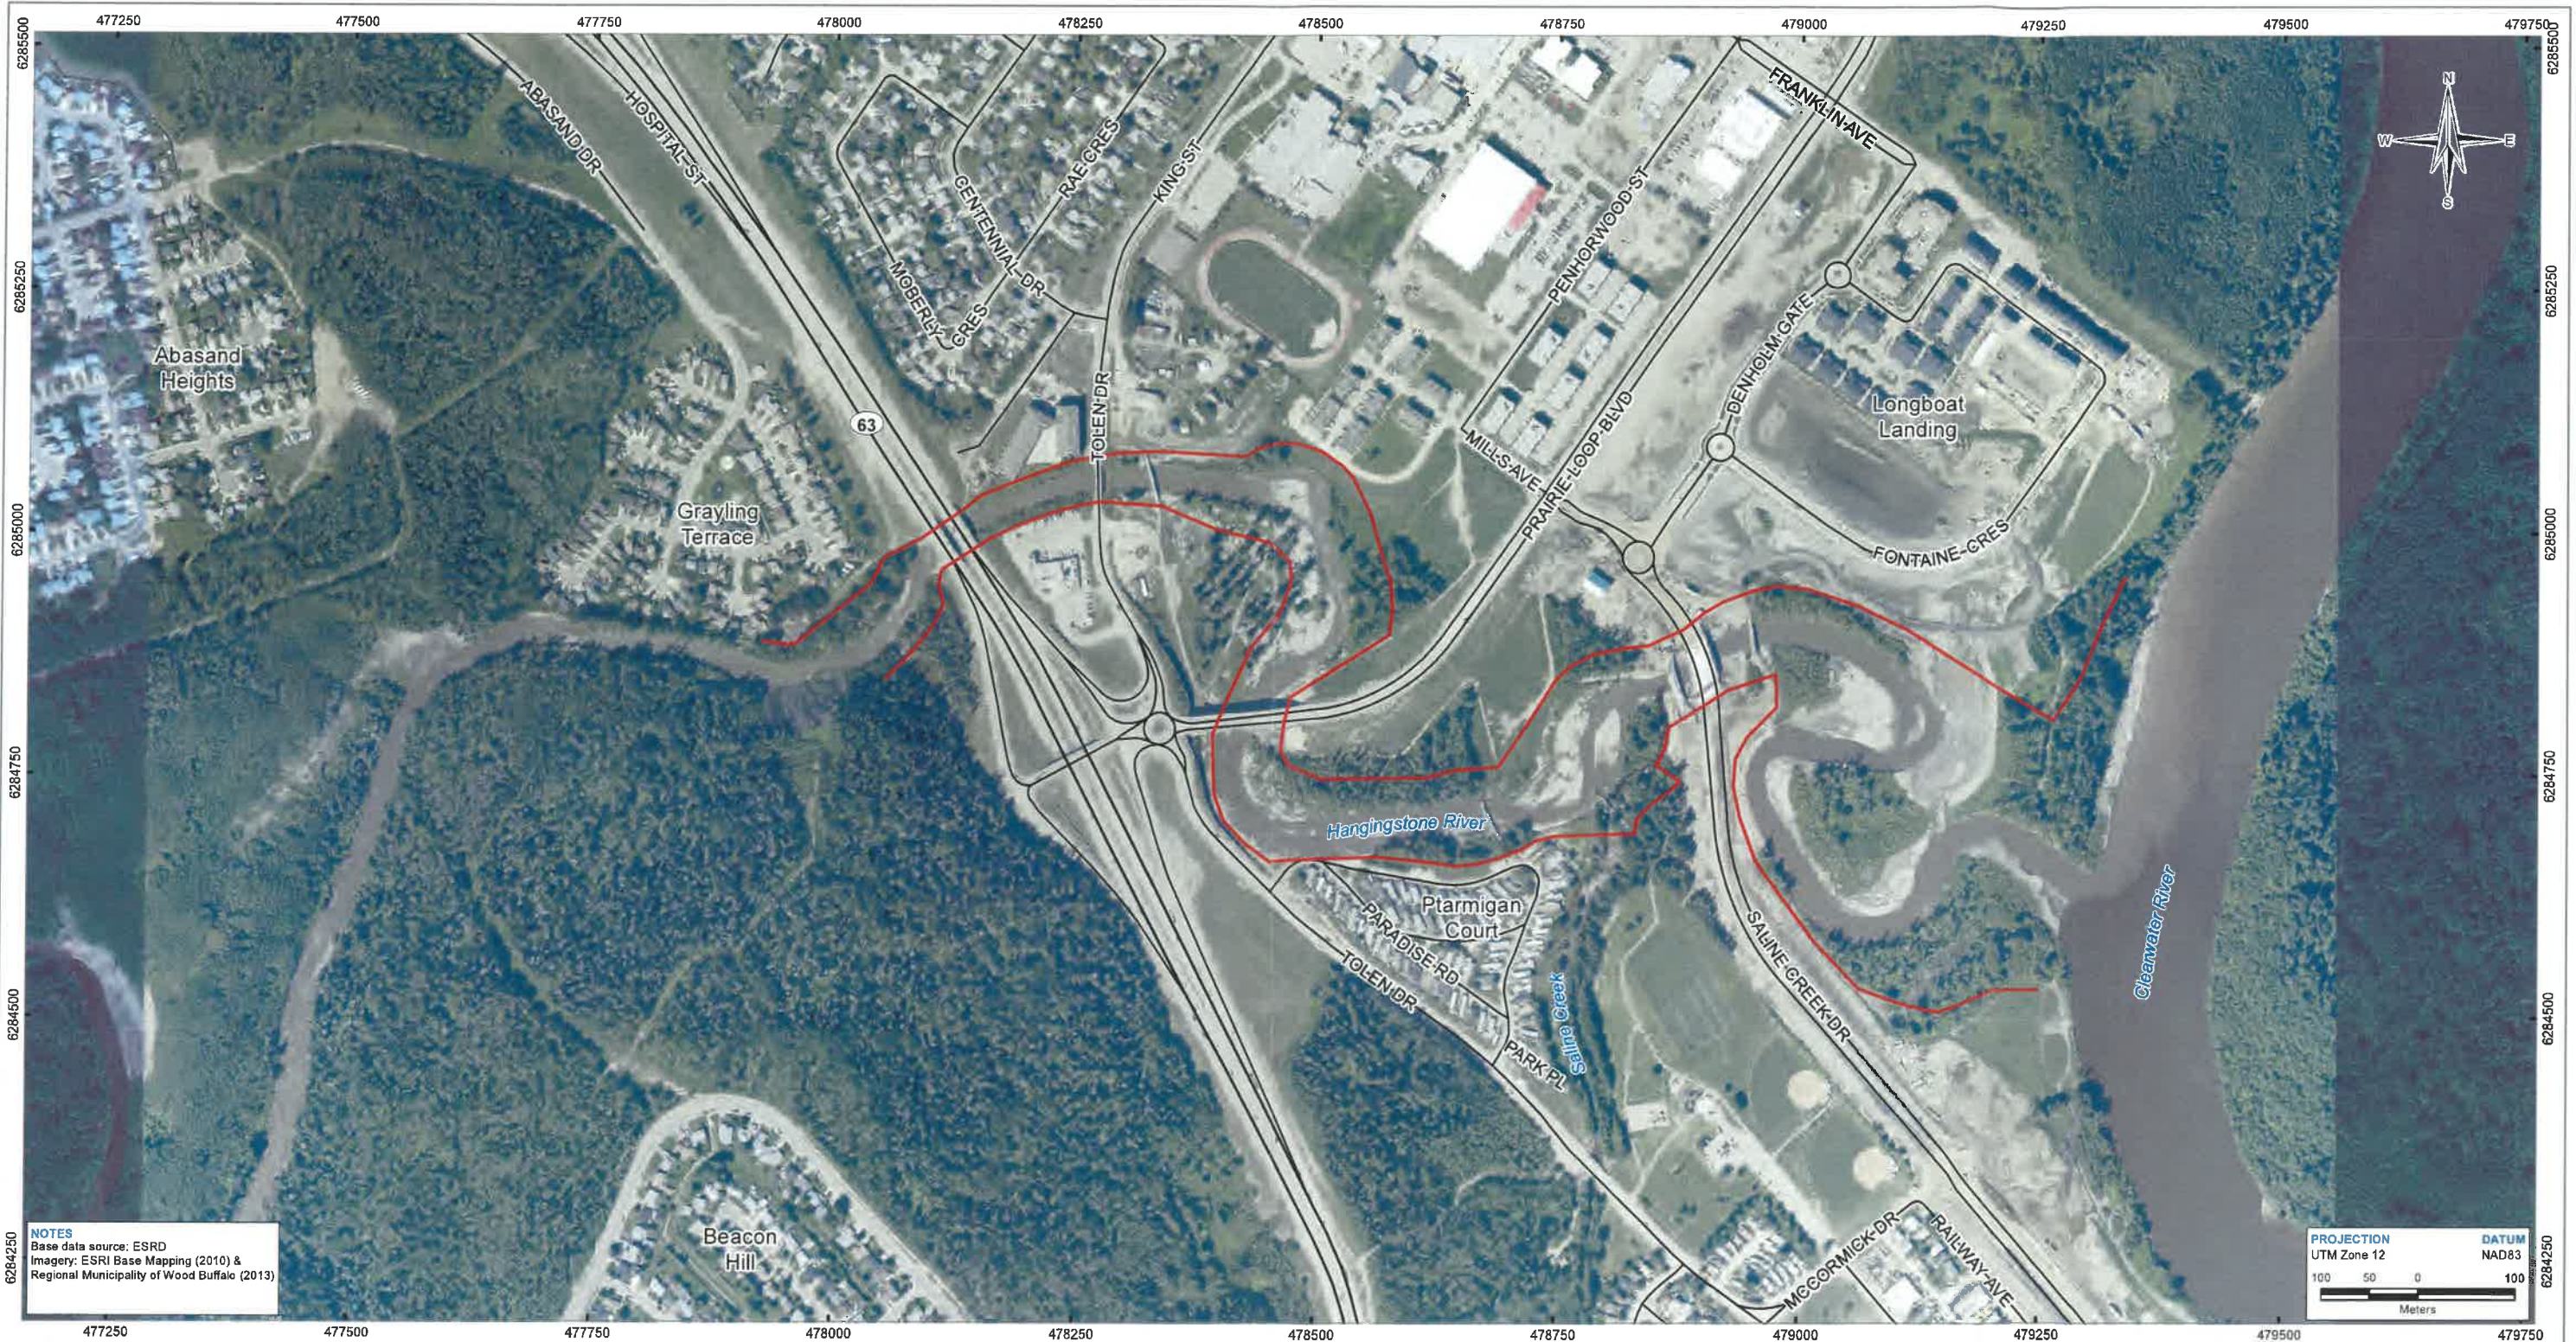
**Figure 21**

Figure 20	Channel Shifting during 2013 Flood, Hangingstone River at Fort McMurray
Figure 21	Buffer Lines drawn 30 metres from 2013 Post-flood Edge of Bank
Figure 22	Preliminary Proposed Setback Buffer for Hangingstone River Flood Control Works

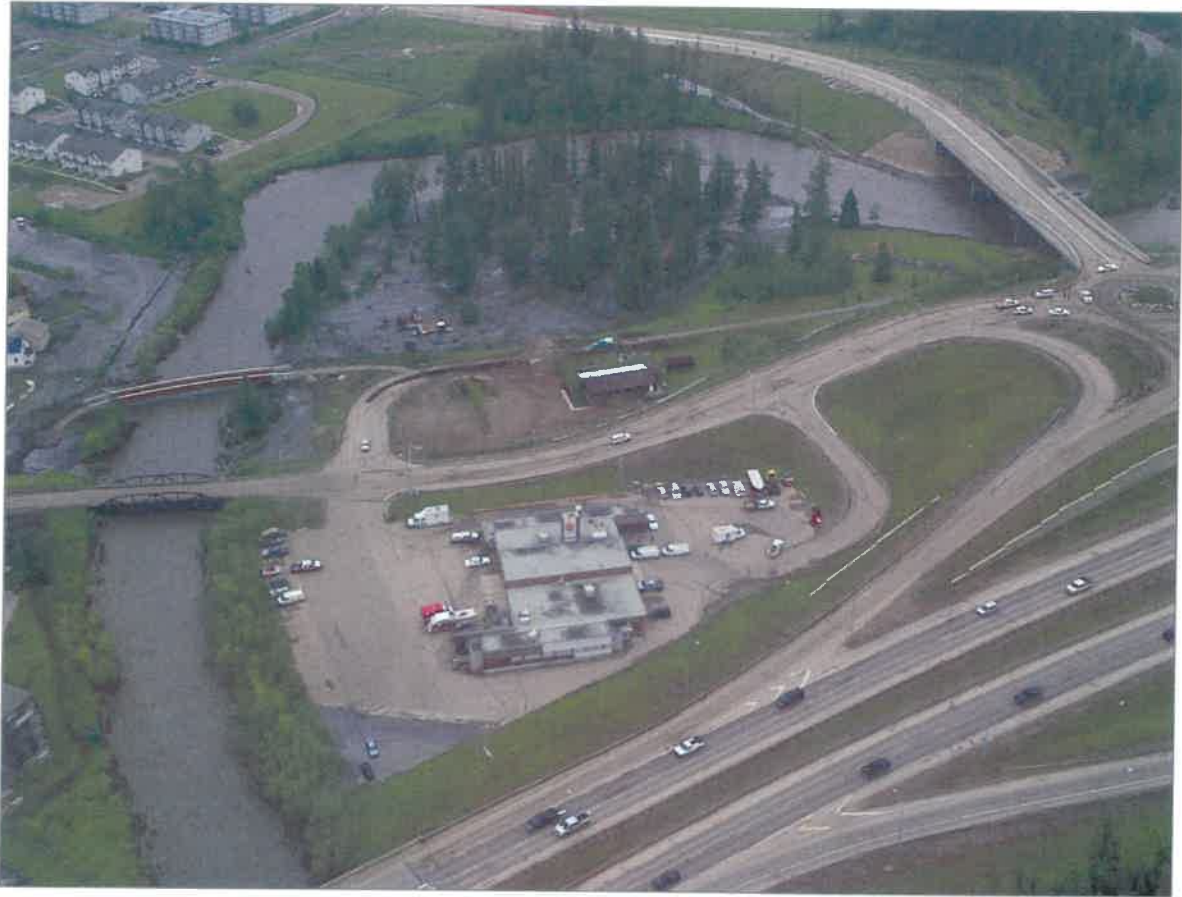
**Photo 1.** June 12, 2013, 9:35 a.m.

Hangingstone River viewing downstream from above Highway 63 bridge to: (1) Tolen Drive bridge, (2) pedestrian bridge, and (3) Prairie Loop Blvd bridge. RMWB Firehall No.1 is situated in the middle part of the photo adjacent to Highway 63. The grey area in the lower left of the firehall parking lot shows the flood event high water mark, and the small green structure on the opposite bank from the parking lot is the Water Survey of Canada stream gauge for the Hangingstone River at Fort McMurray. Additional grey areas (silt deposits) downstream of the Tolen Drive bridge show where overbank flooding occurred.

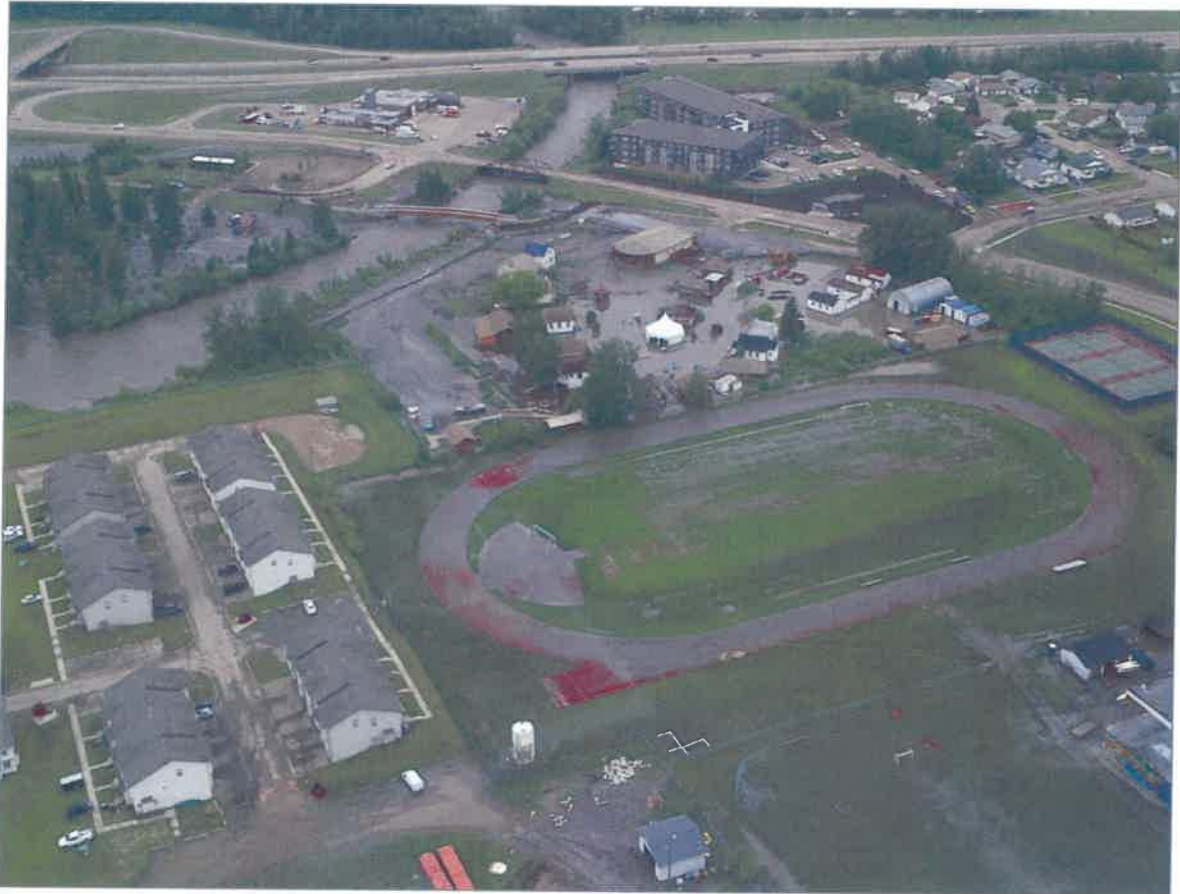
**Photo 2.** June 12, 2013, 9:35 a.m.

Hangingstone River viewing upstream, showing residual flooding at Heritage Park in middle of photo. Highway 63 is at top of photo.

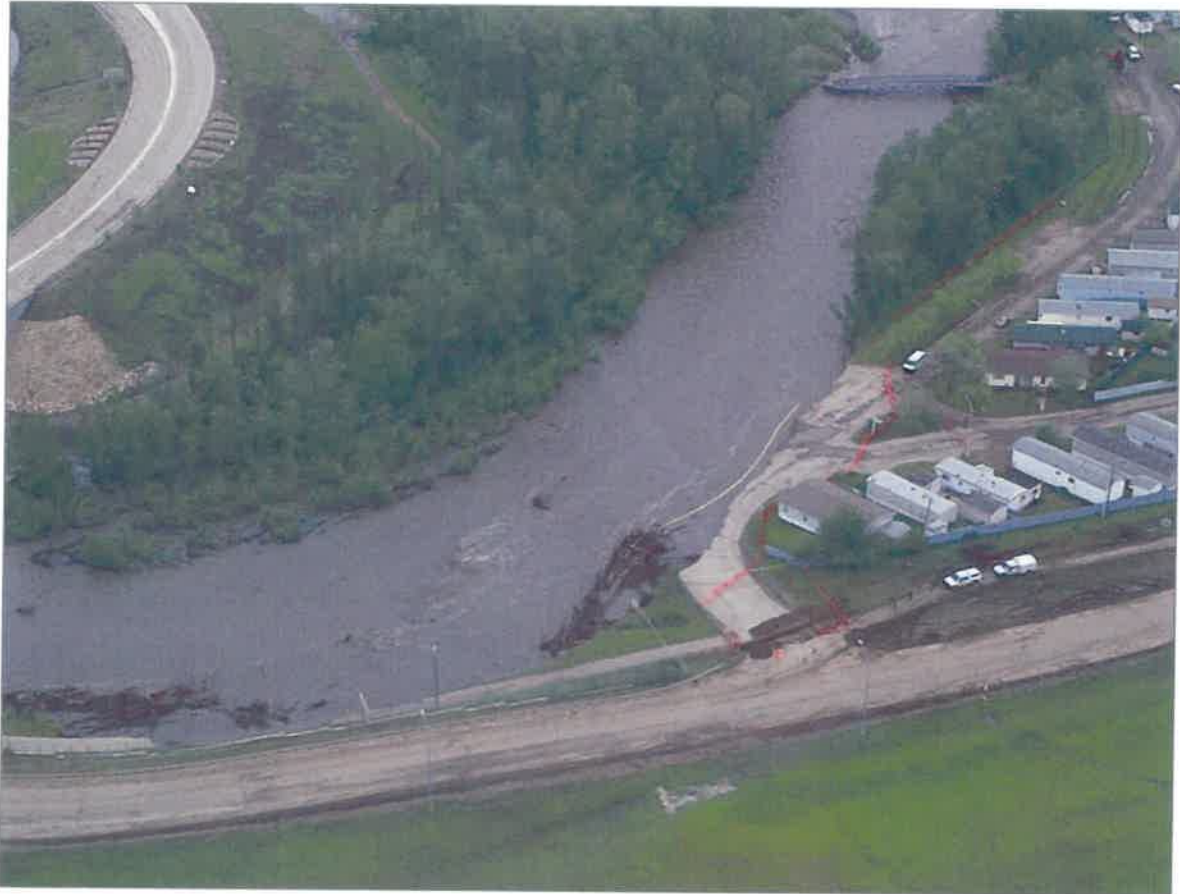
**Photo 3.** June 12, 2013, 9:36 a.m.

Hangingsstone River viewing downstream to erosion sites at Tolen Drive (at bottom of photo), Ptarmigan Court, and pedestrian bridge.

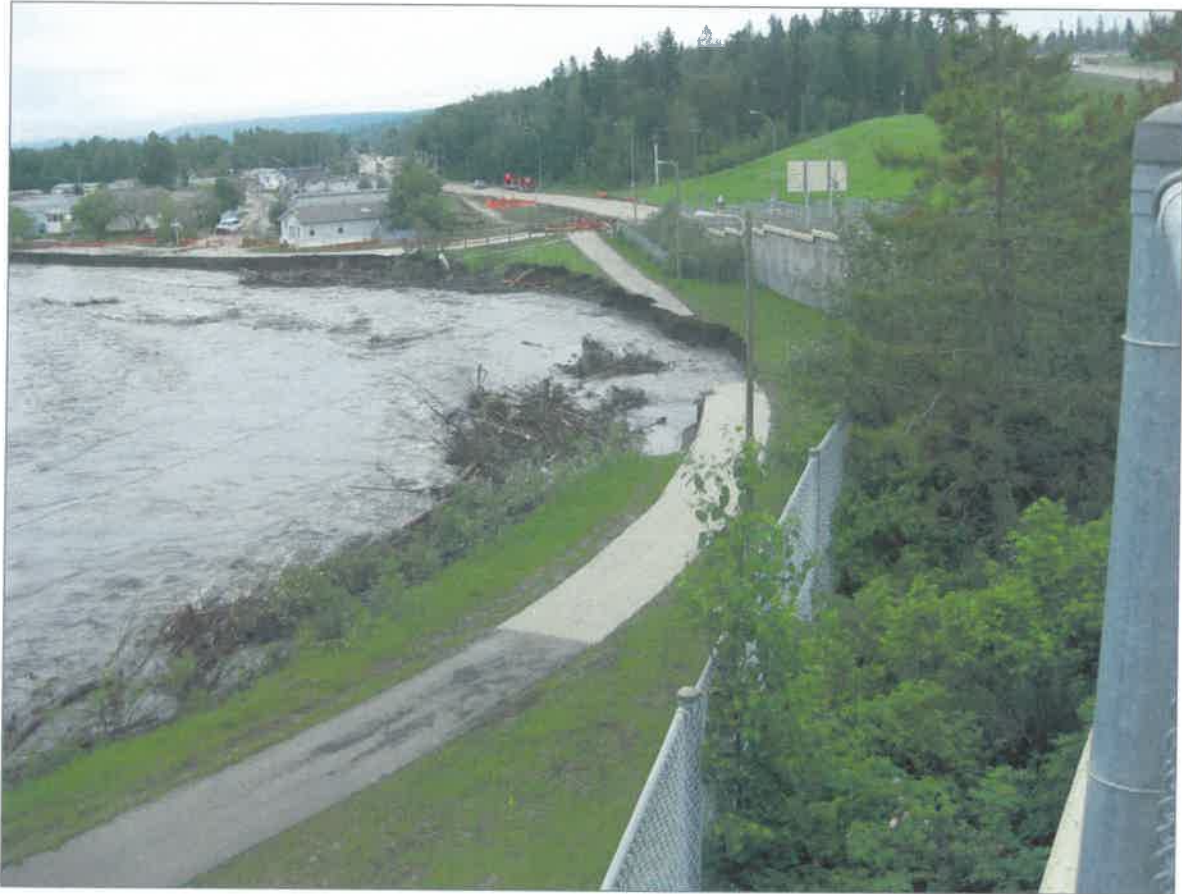
**Photo 4.** June 12, 2013, 9:58 a.m.

Viewing downstream to erosion sites at pedestrian trail parallel to Tolen Drive (at right side of photo), and Ptarmigan Court.

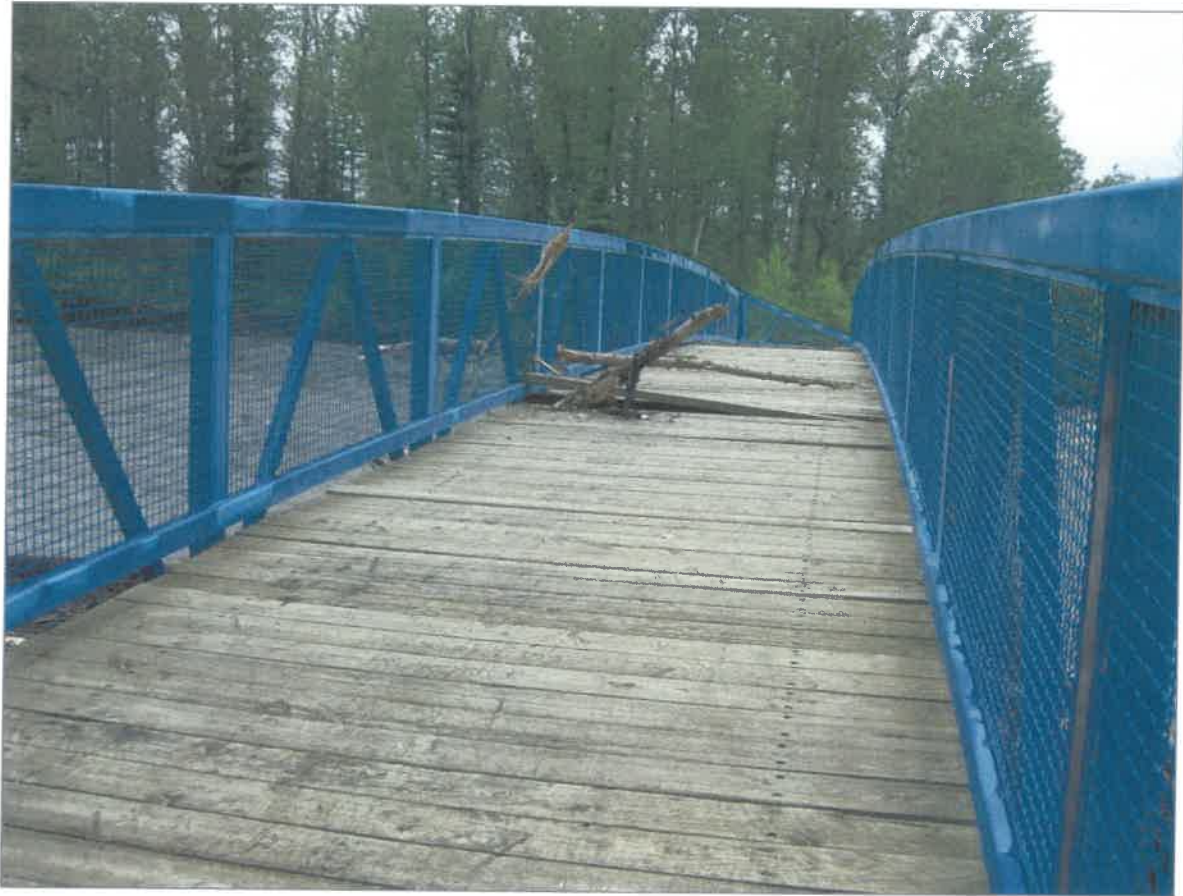
**Photo 5.** June 12, 2013, 10:13 a.m.

Viewing north to Hangingstone River flood debris lodged in deck of pedestrian bridge adjacent to Ptarmigan Court.

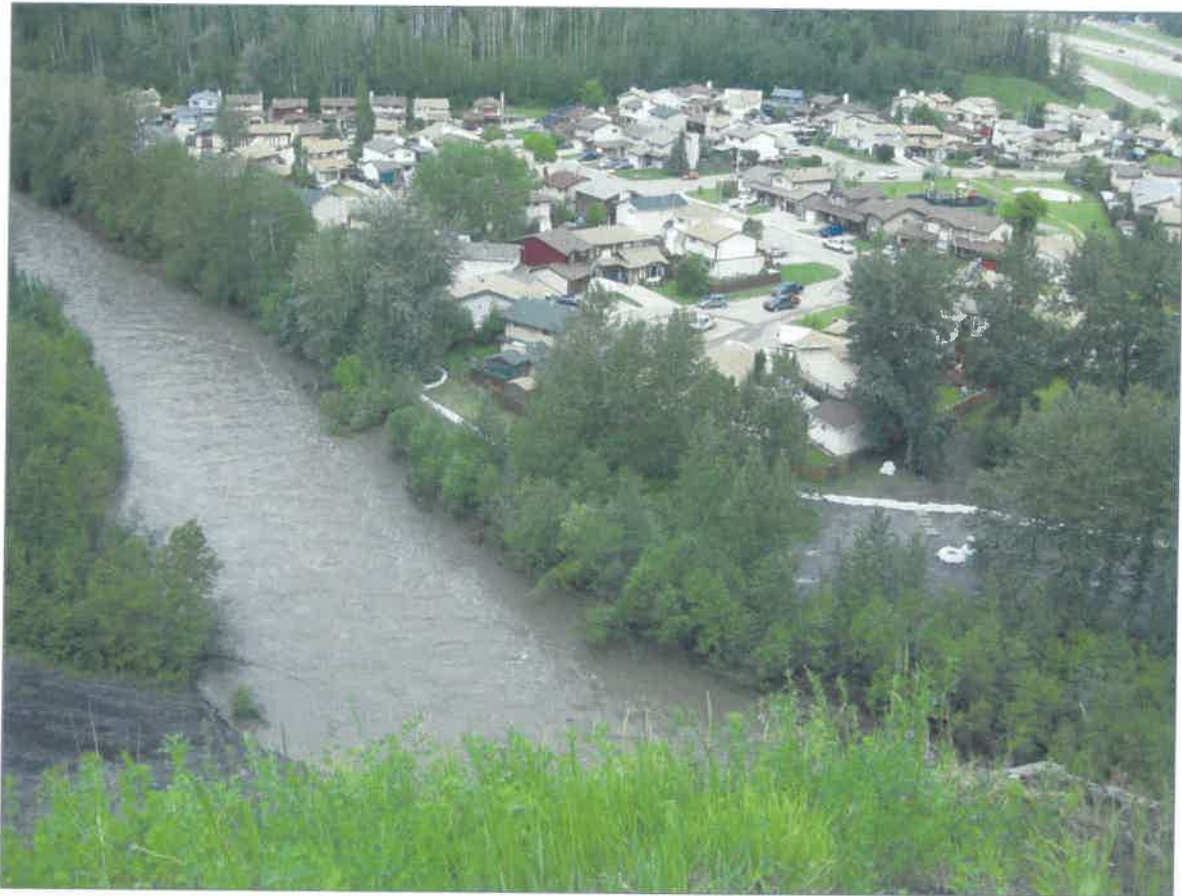
**Photo 6.** June 13, 2013, 11:58 a.m.

Hangingsstone River viewing upstream at Grayling Terrace showing sandbags placed along top of bank. Area of concern for landslide hazard, and the potential to obstruct the river flow, is at the left edge of photo.

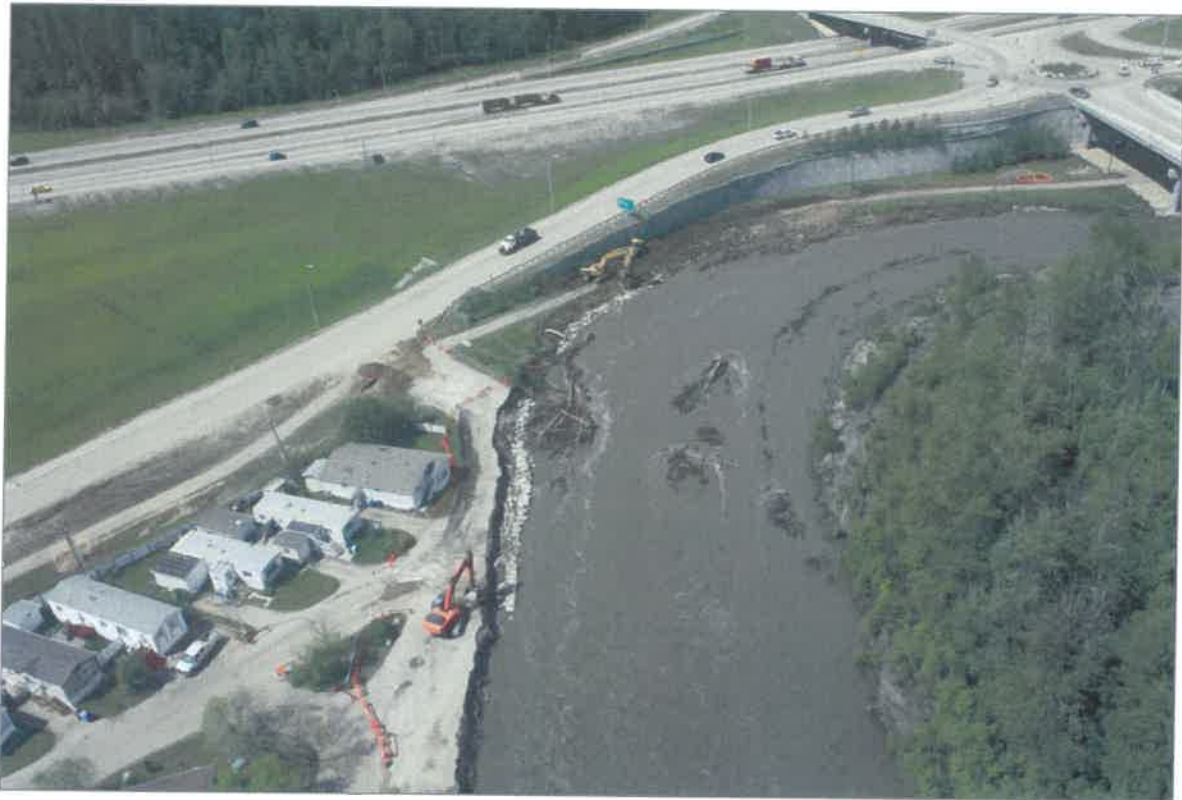
**Photo 7.** June 14, 2013, 12:18 a.m.

Hangingstone River viewing upstream to bank repairs works along Ptarmigan Court and Tolen Drive.

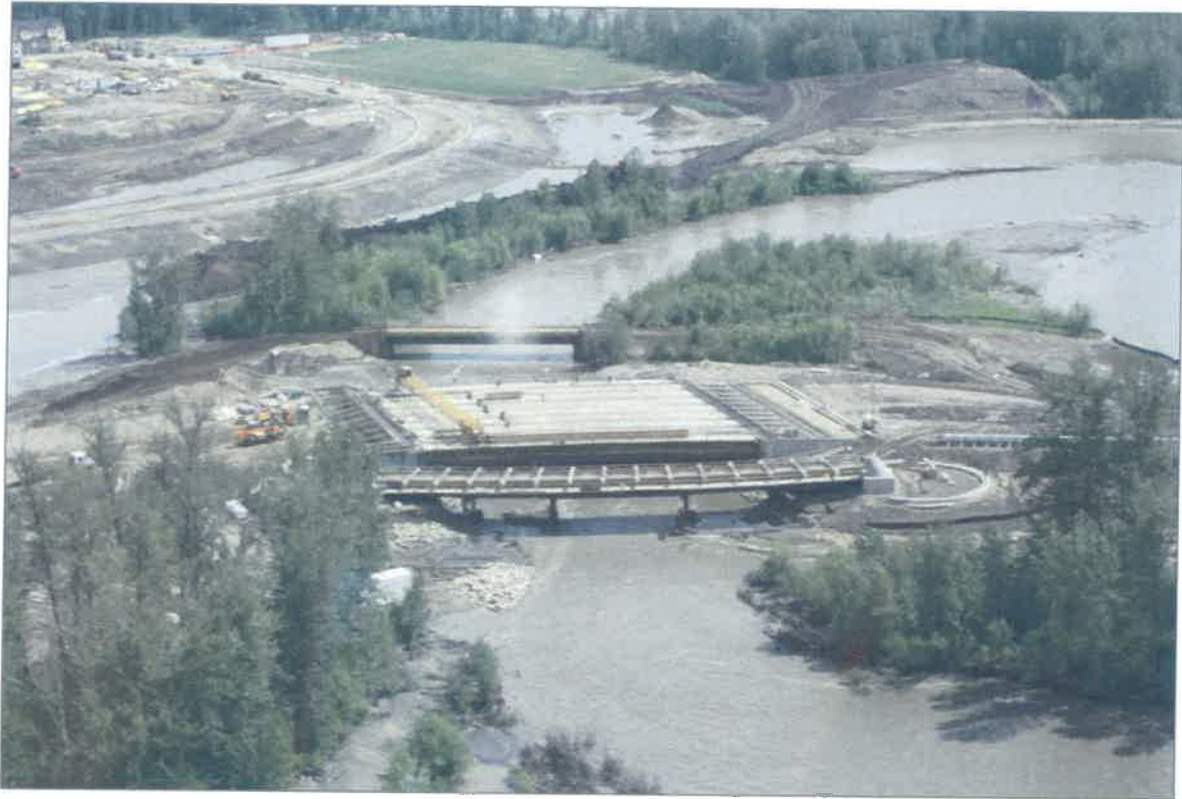
**Photo 8.** June 14, 2013, 12:19 p.m.

Hangingsstone River viewing downstream at Saline Creek Drive bridges under construction. The proposed Longboat Landing development is under construction in the upper left portion of the photo.

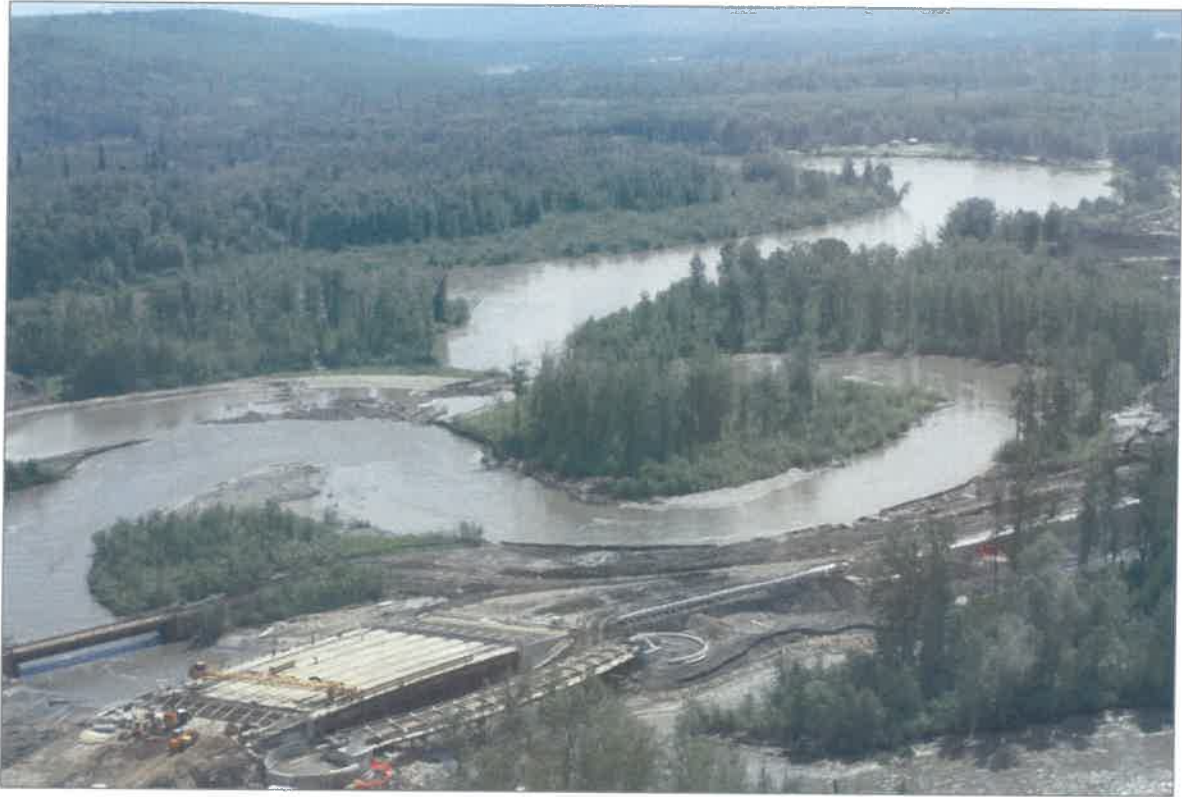
**Photo 9.** June 14, 2013, 12:19 p.m.

Hangingstone River viewing downstream to confluence with the Clearwater River flowing right to left at top of photo.
