## HANGINGSTONE RIVER BASIN STUDY

PRESENTED TO  
**Regional Municipality of Wood Buffalo**

JUNE 2015  
ISSUED FOR USE  
FILE: ENVH2O03100-01

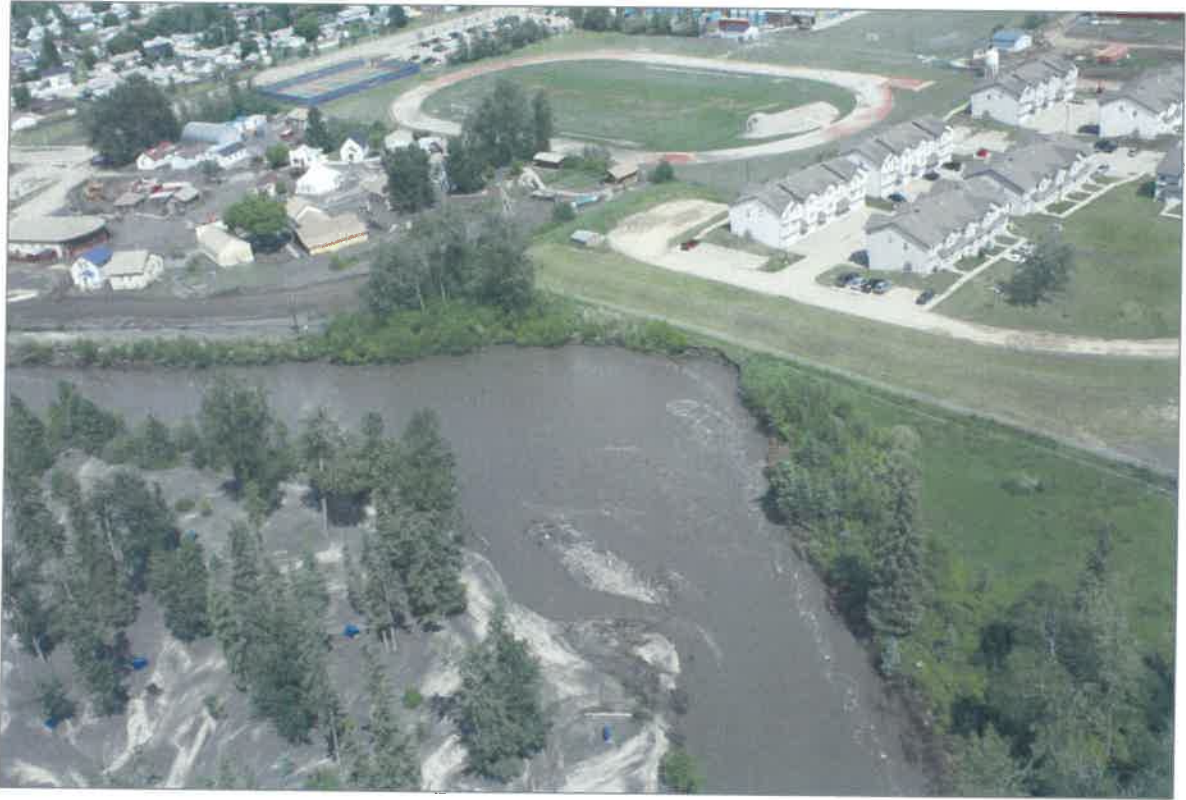
**Photo 10.** June 14, 2013, 12:23 p.m.

Hangingsstone River viewing upstream to localized bank erosion at outside bend downstream from Heritage Village.

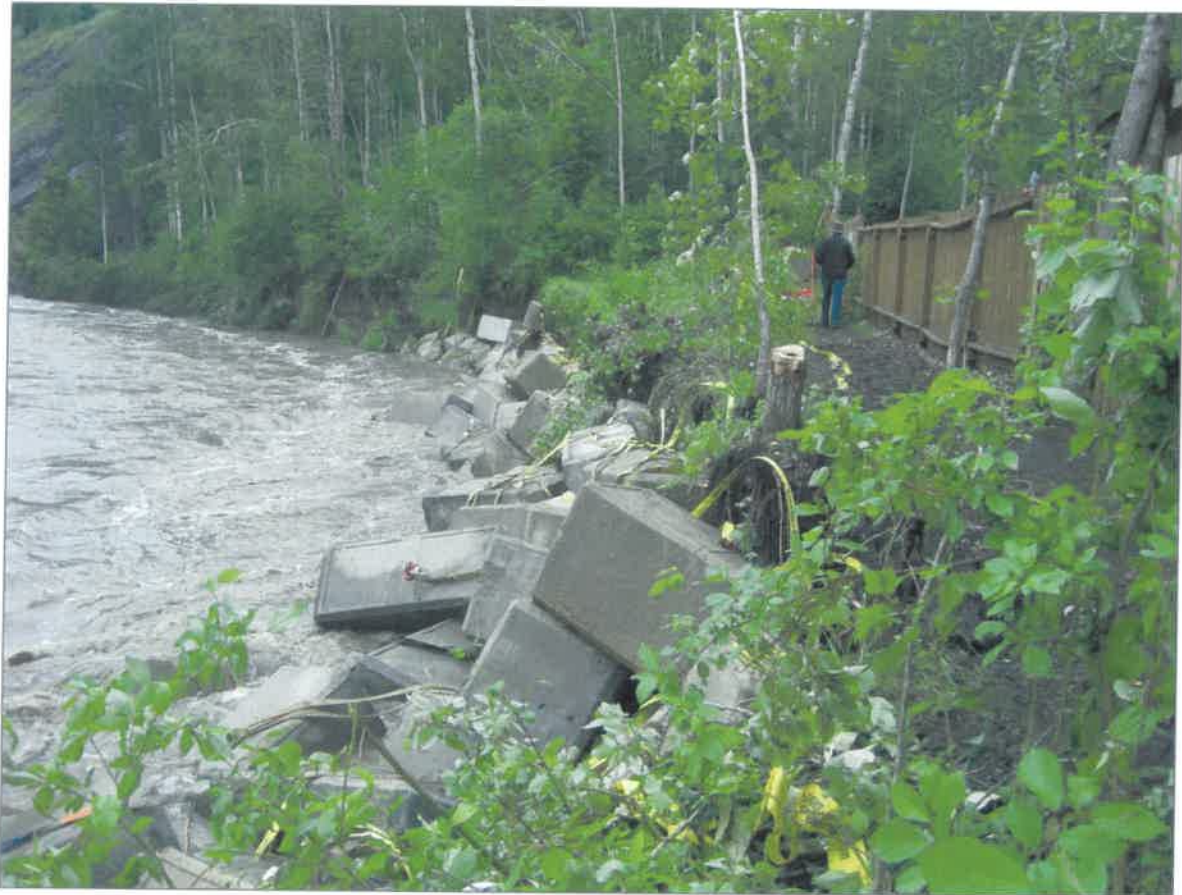
**Photo 11.** June 15, 2013, 5:41 p.m.

Hangingsstone River viewing upstream showing concrete block bank protection installed at upper end of Grayling Terrace.

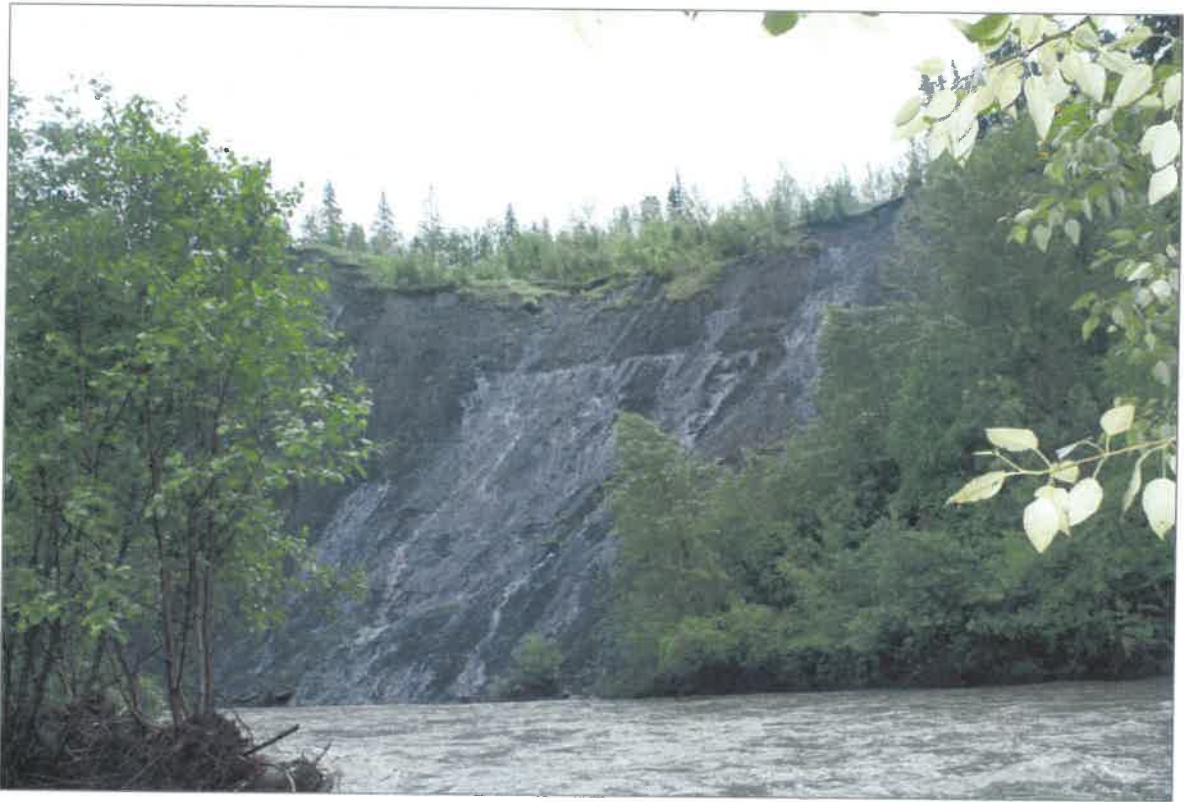
**Photo 12.** June 15, 2013, 8:15 a.m.

Hangingstone River viewing south from Grayling Terrace to landslide area of concern on opposite bank.  
River flow is right to left.

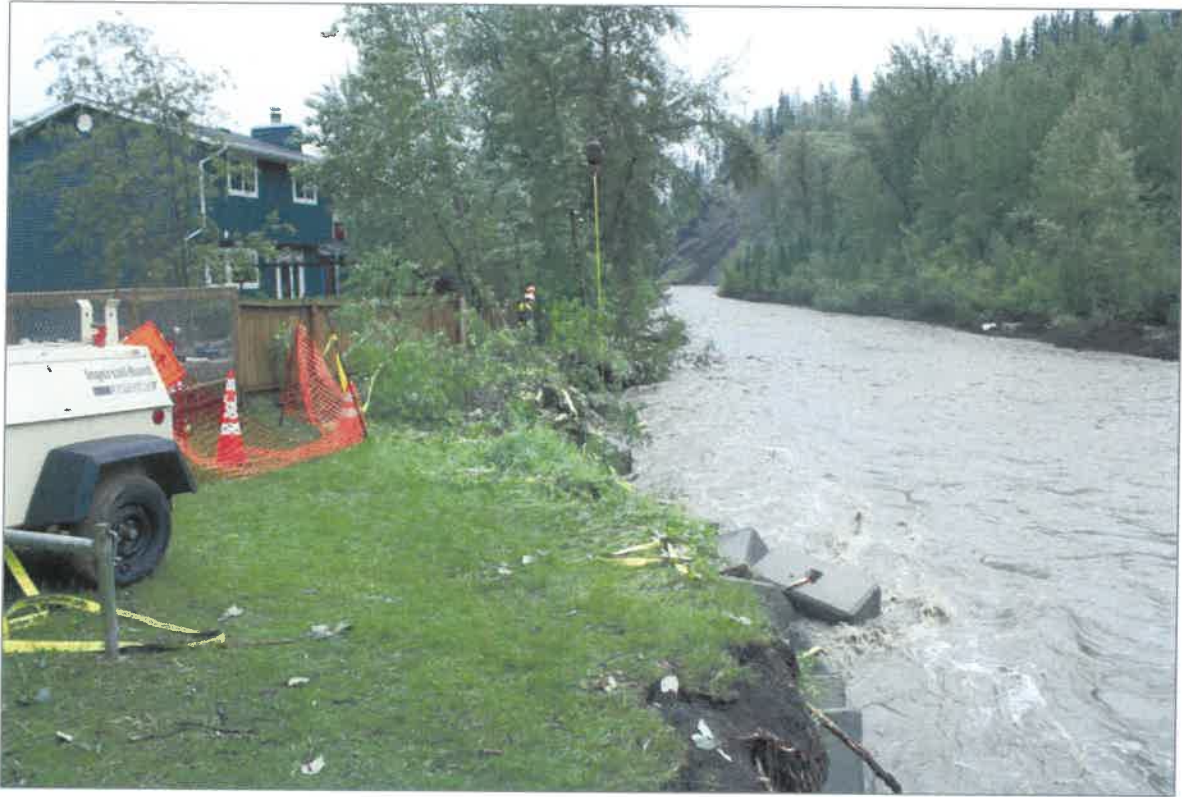
**Photo 13.** June 15, 2013, 8:21 a.m.

Hangingstone River viewing downstream from upper end of Grayling Terrace.

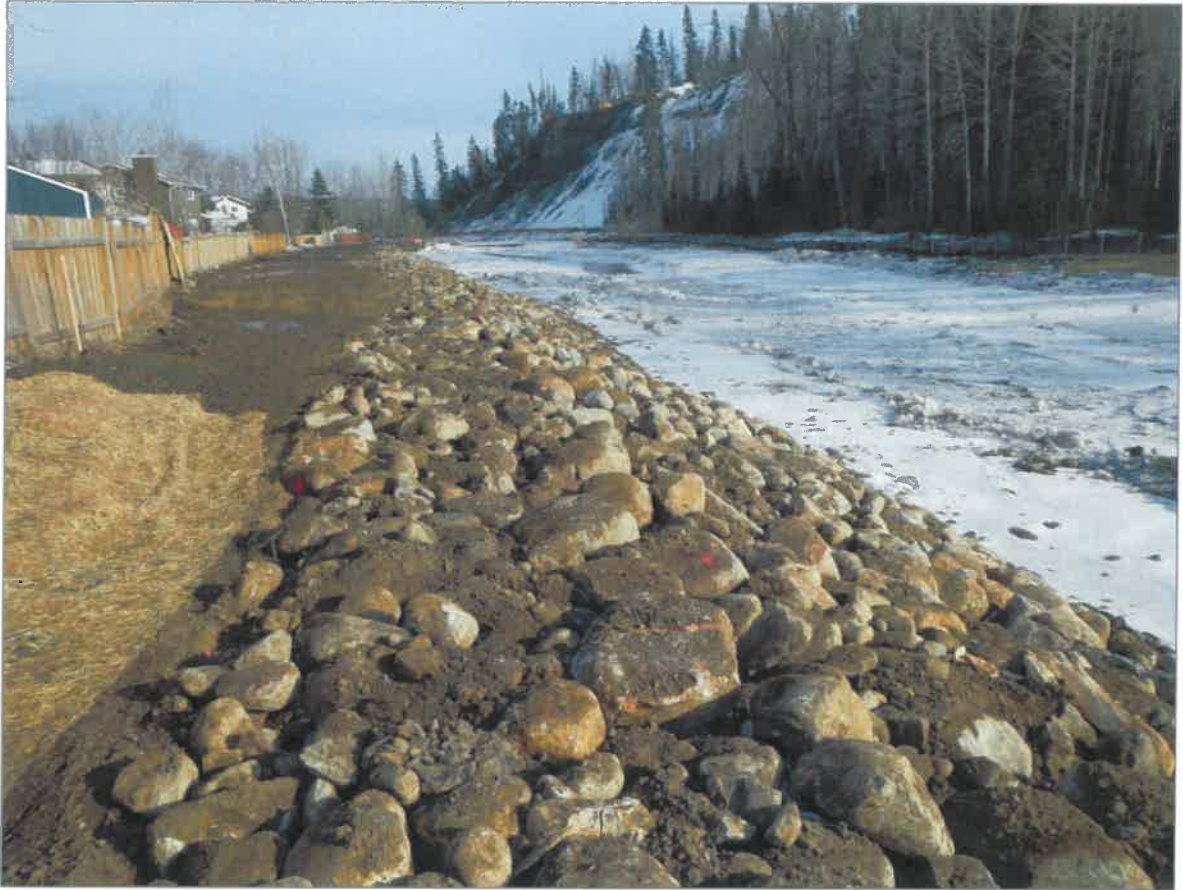
**Photo 14.** March 12, 2015.

Hangingstone River viewing downstream from upper end of Grayling Terrace after recent (2015) construction of channel conveyance improvements, prior to landscape restoration. Work was also done in early 2015 to stabilize the landslide hazard area on the right bank.
